■ Process: Dust Removal in a Packing Station in Gypsum Industry

Process Manufacturing of Gypsum Products and the Solution of the Dust Problem

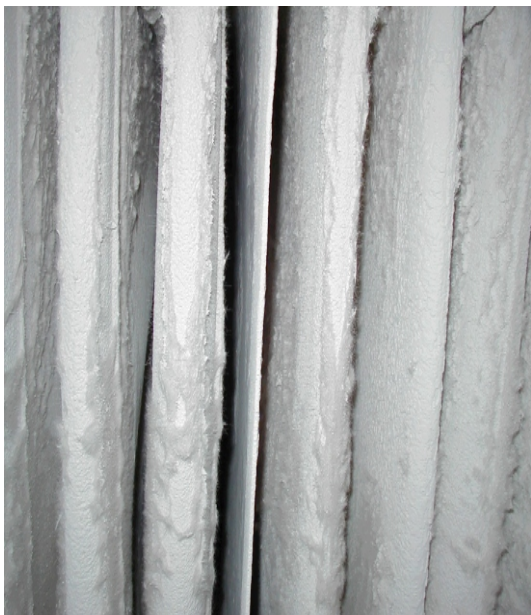
Within the sacking station of Turmgips an annual change of fabric filters was necessary (see picture front page left).

In the past for dedusting of the different process steps the German company Turmgips mainly used filter units equipped with woven polyester filter bags or pocket filters. In combination with humidity a hard layer of gypsum builds up on the surface of these filter elements.

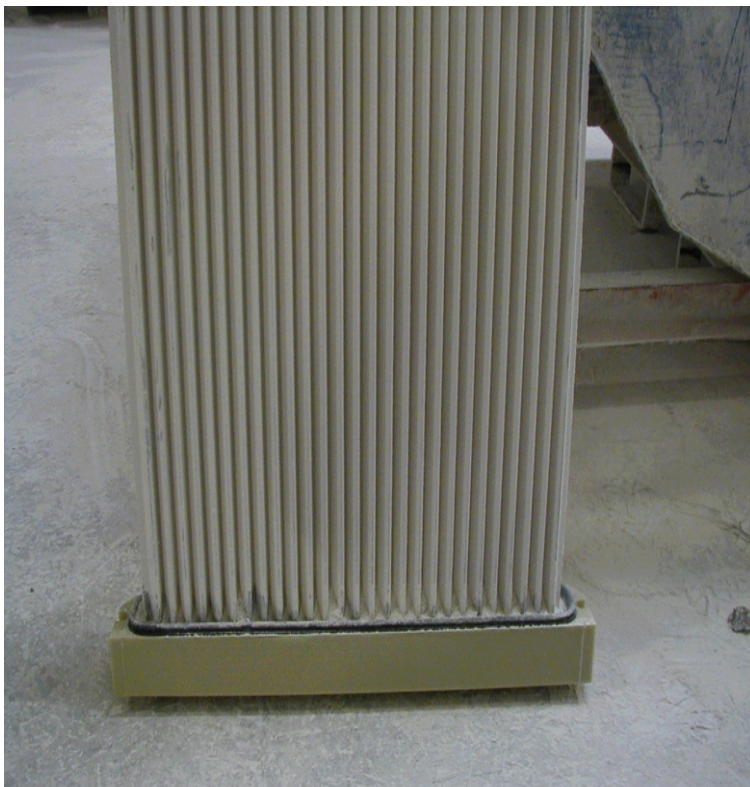
On the other hand the Herding Sinter Plate Filter used in the same application, does not show any damage or dust deposition (see picture left). Hence, maintenance intervals of Herding filter units are extremely long.

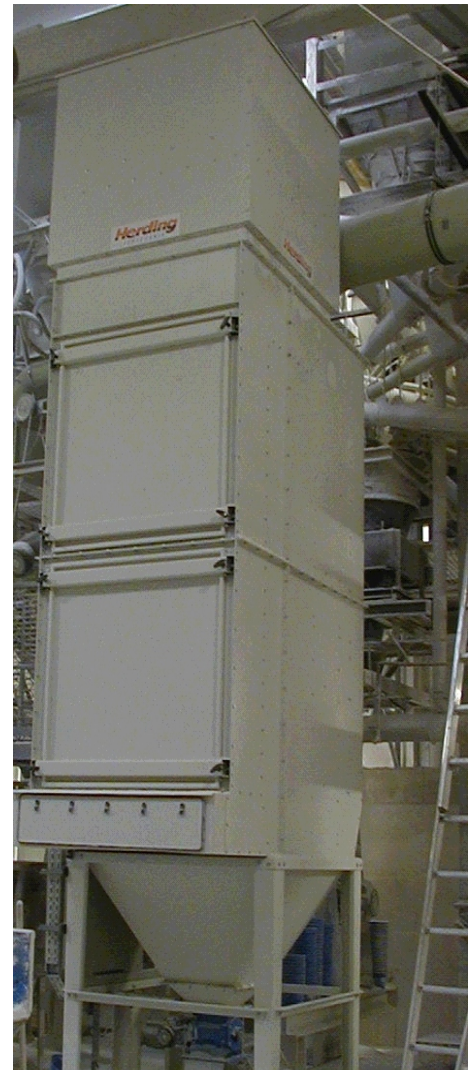
In summer 2001, the existing high maintenance fabric filter unit was replaced by a Herding® filter unit, type DELTASys 1500-48/9 SZ with Sinter Plate Filterelemente (picture back page top right). Since this point in time, the Herding filter unit DELTASys is operated with extremely low pressure drop and constant air flow. Due to the Herding filter unit's extremely low residual dust content as well as its high operational safety the clean gas can be re-routed back into the production facilities, saving heating cost during the winter period.

Operation of the new Herding DELTASys has shown significant improvement in handling of light and fibrous dust components. Applying the down flow principle in combination with the filter element's rigid body design, the system allows for significantly higher filter area loading.
